A Complication of Intraoperative Facial Nerve Monitoring: Facial Skin Burns

Objective: To report on three cases of severe facial skin burns resulting from intraoperative facial nerve monitoring in patients undergoing parotidectomies.

Am J Otol 20: 679-682, 1999.

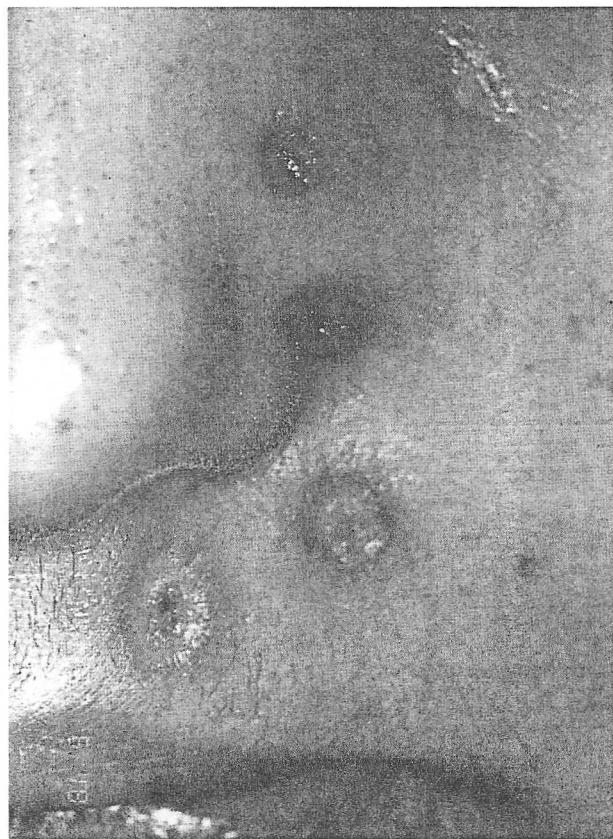
A 47-year-old woman underwent a total parotidectomy, radical neck dissection, partial composite mandibular resection, and reconstruction with a fibula free flap and pectoralis major myocutaneous flap for an osteosarcoma of the left mandible. Intraoperative FNM was conducted using the Neurosign 100 (MAGSTIM Company Limited, U.K.) apparatus with habitual electrode configuration. After this 18-hour procedure, the surgeons discovered large skin injuries at the electrode implantation sites. Skin defects were 2 × 3 cm in width (Fig. 1). Electrical skin burns were

FIG. 1. Photograph of Case 1, 5 days after parotidectomy, radical neck dissection, partial composite mandibular resection, and reconstruction with a fibula free flap and pectoralis major myocutaneous flap for an osteosarcoma of the left mandible. Large skin burns located at facial nerve monitoring electrode implantation sites were found at the end of the 18-hour procedure. Skin defects were 2 cm in width, more marked and ulcerated at reference electrode sites (paranasal area).

attributed to a short circuit caused by prolonged contact with soaked draping. Postoperative outcome was marked by infection of the lesions, requiring a course of intravenous antibiotics and repeated wound debridement of necrotic material. Further healing finally generated marked indurated fibrotic lesions at each electrode implantation site.

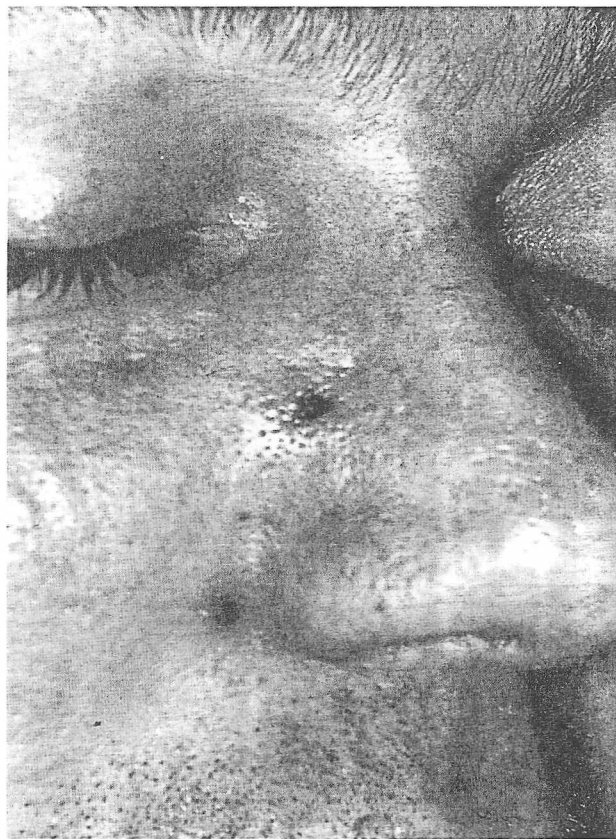
A 37-year-old man underwent a subtotal parotidectomy for chronic parotitis. Usual FNM was used. At the end of the surgery (3 hours), facial skin burns centered on all six electrode implantation sites were present (Fig. 2). During the following 8 months, the lesions regressed only partially. The patient may request corrective surgery.

FIG. 2. Photograph of Case 2, 3 days after parotidectomy performed in conjunction with intraoperative facial nerve monitoring. The facial skin burns centered on electrode implantation sites are demonstrated. The most severe lesions were found in the paranasal area where the reference electrodes were inserted (see text).
